A STUDY OF HIGH POWER ARGON LASER OPTICS

FINAL REPORT

Contract NAS 12-548

RAYTHEON COMPANY
Research Division
Waltham, Massachusetts

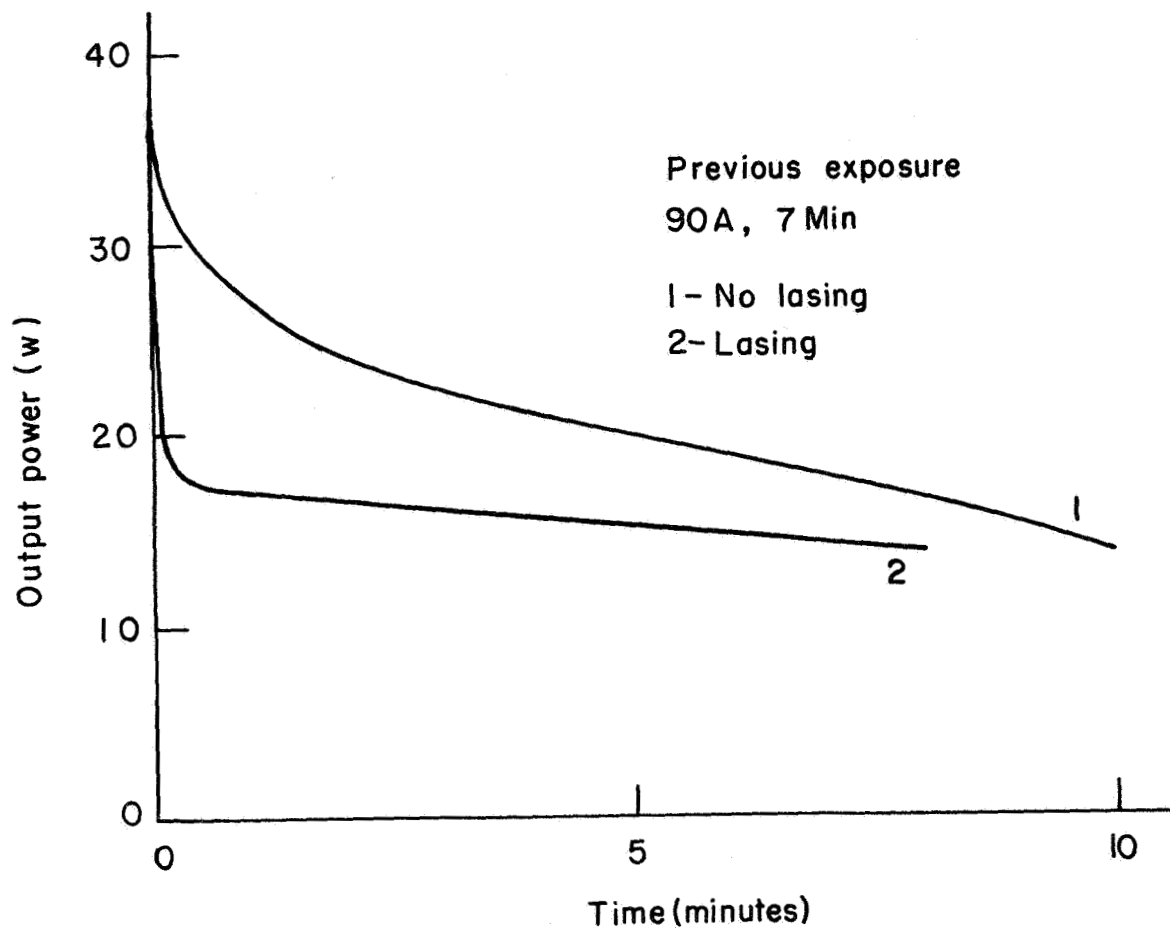
FIGURE 14

or nonpresence of the beam, prior window exposure was made at a higher discharge current (90 A) than that (70 A) used in the earlier tests. Figure 14 shows the relative effects of a seven-minute exposure to a 90 A discharge, lasing and nonlasing, on operation at the 70 A level. In this case there was evidently quite a difference between the lasing and nonlasing situations. The presence of the laser beam seemed to increase the damage rate significantly.

OUTPUT POWER DECAY USING WINDOWS PREVIOUSLY EXPOSED TO
LASING AND NONLASING DISCHARGE

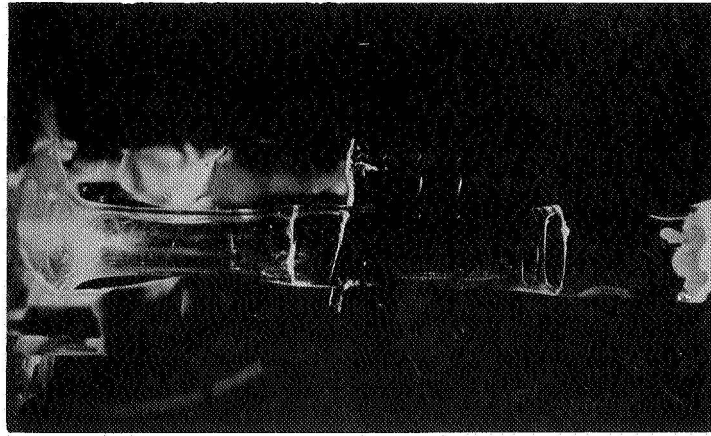
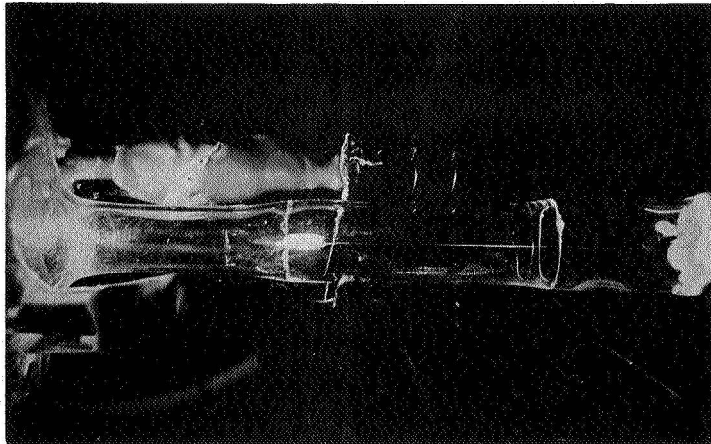
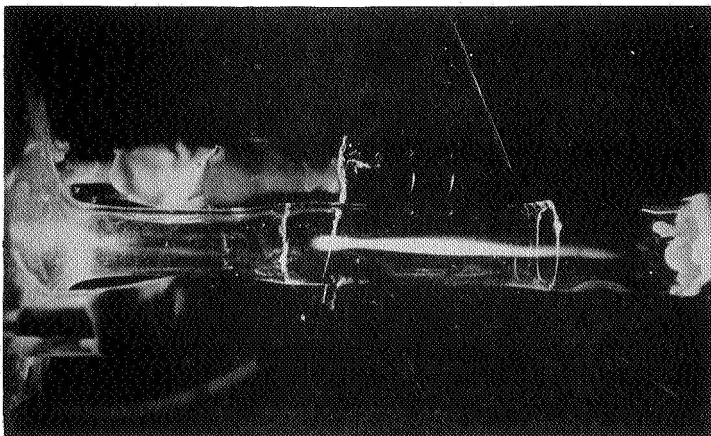
This particle transport is shown in the photos in Fig. 21 which view the section of the envelope between the anode bulb and the first bellows (B_1). In Fig. 21b the confined stream of particles and the terminating cusp formation are visible. The initial dispersal of the particles after removal of the ground connection is pictured in Fig. 21c. Similar particle behavior was noted at the cathode end of the structure when a potential of 200 V was established between the two bellows sections.

a) No potential gradient

b) Gradient established: Particle streaming

c) Gradient removed: Particle dispersal

Fig. 21 Particle Transport in the Region between the Anode and the End Bellows: Anode-Bellows Potential Difference 600V

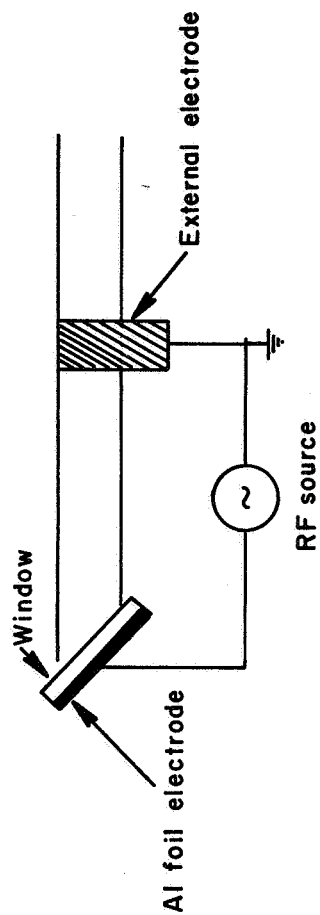
FIGURE 22

EFFECT OF ARGON SPUTTERING OF DEGRADED WINDOW ON OUTPUT
(PYROLYTIC GRAPHITE BORE LASER; ARGON PRESSURE 450 MTORR)

In further tests, film removal by argon sputtering proved to be quite effective even with normal gas fill pressures. Degraded windows located at either the cathode or anode end of the laser structure were restored by this means. These results were obtained for the pyrolytic graphite bore laser (Fig. 22) as well as the principal laser. Later it was determined that the sputtering could be accomplished using a Tesla coil as the rf source. Although the windows were restored to their original condition by the sputtering action, renewed film deposition commenced soon after the sputtering ceased. Additional tests with Tesla coil applications of the rf to the region of the mounting tube away from the window while the laser was operating showed that, not only was film removal accomplished, but also that film regrowth was somewhat inhibited.
